J & R Inspections

Property Inspection Report

123 S Somewhere St., Nowhere, CA 12345
Inspection prepared for: Current Client
Real Estate Agent: Ed Brown - Brown Relaty

Date of Inspection: 5/23/2012 Time: 5:30 PM
Weather: Clear

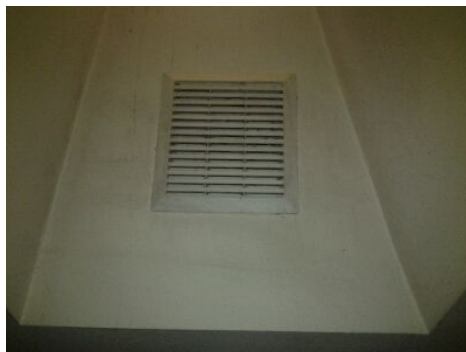
- This laundry room exhaust fan appeared to be inoperable at the time of the inspection. This condition may result in damage to laundry room components from excessive humidity.

The Inspector recommends fan repair or replacement with an adequately sized exhaust fan be performed by a qualified carpenter.

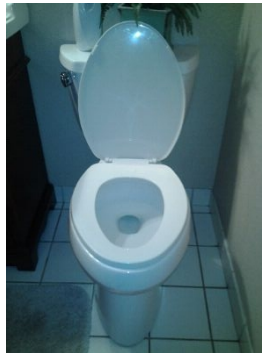
- Loose at the concrete floor

The toilet was loose at the concrete floor indicating that anchors designed to secure the toilet to the floor have pulled loose.

A variety of solutions may be available, depending on the exact nature of the problem. The Inspector recommends re-attachment.

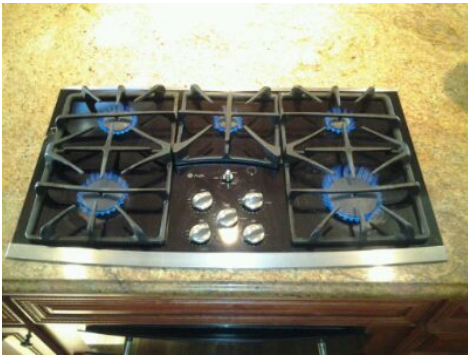
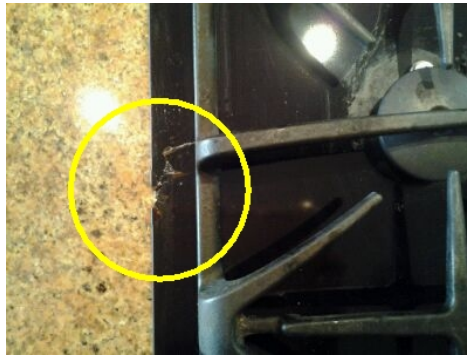
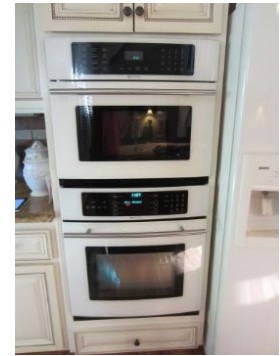
Chip on stove top

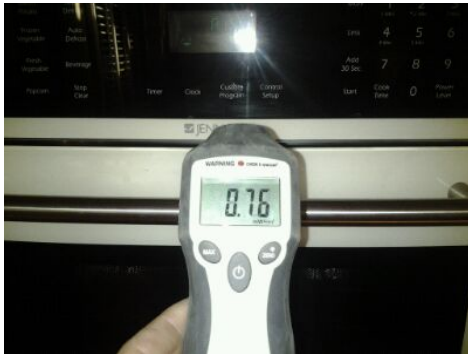
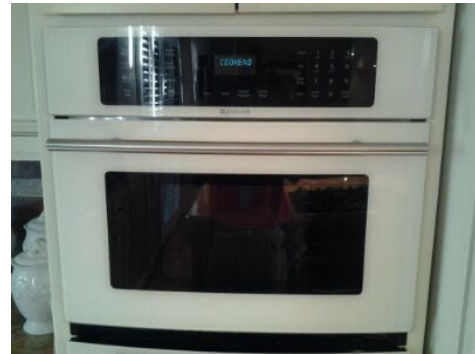
Observations: Microwave operated good., We used a radiation tester to see if there was leakage while in operation., There was no excess radiation leakage above upper limit present at time of inspection.

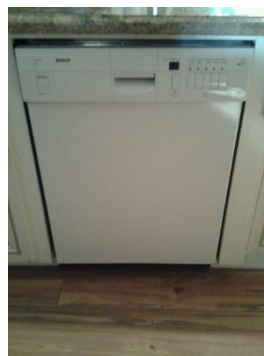
The dishwasher was operated through a partial cycle and appeared to be in serviceable condition at the time of the inspection.

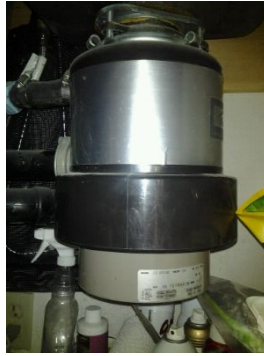
- Garbage disposal operated fine at time of inspection.

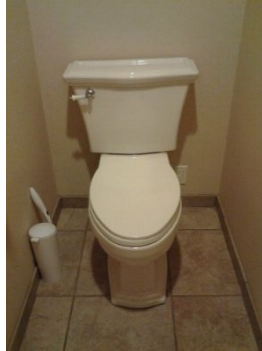
- Loose at the concrete floor

The toilet was loose at the concrete floor indicating that anchors designed to secure the toilet to the floor have pulled loose.

A variety of solutions may be available, depending on the exact nature of the problem. The Inspector recommends re-attachment.

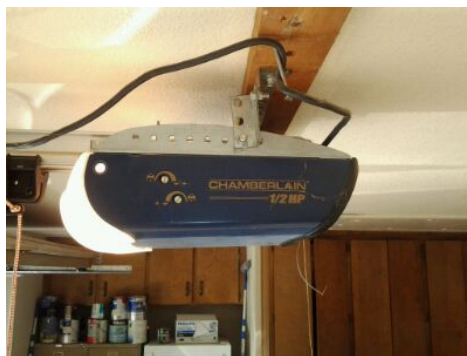
- Operated unit. We recommend applying a dry lubricant of spay silicone on wear parts to quite operation and extend life of opener.

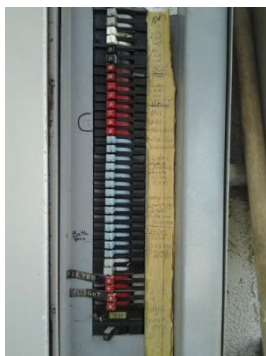
Main electrical service panel contained a Ground Fault Circuit Interrupter (GFCI) breaker designed to provide protection by shutting off current flow should sensors indicate a problem in outlets at protected circuits, the breaker did not trip when test button was pressed.

Labeled well

It is listed as servicing outside and bath outlets. We suggest consulting a qualified electrician.

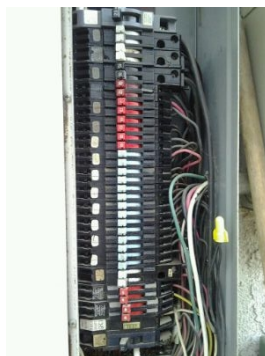
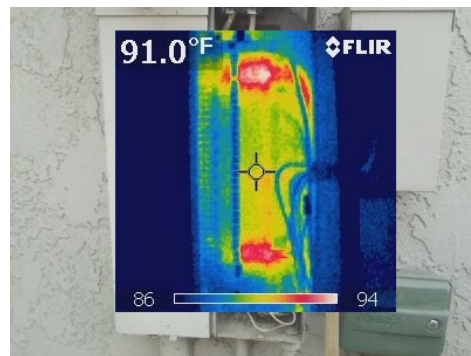
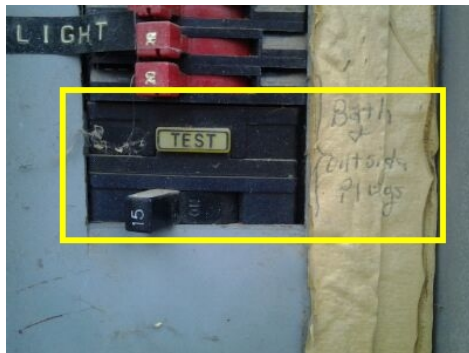
Legend states GFCI breaker for all outdoor and bathroom outlets however bathrooms have own installed

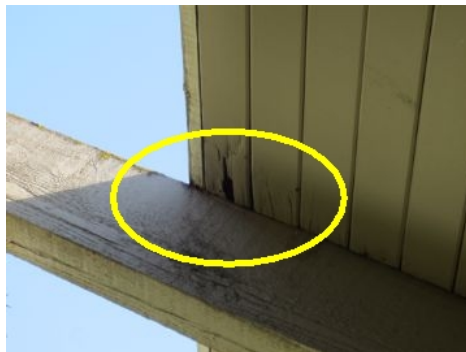
- Soffits at the home above front entry area by door had visible moisture damage such as decayed or deteriorated wood. The source of moisture should be located, the problem corrected to avoid further damage and damaged areas of the soffit should be repaired or replaced.

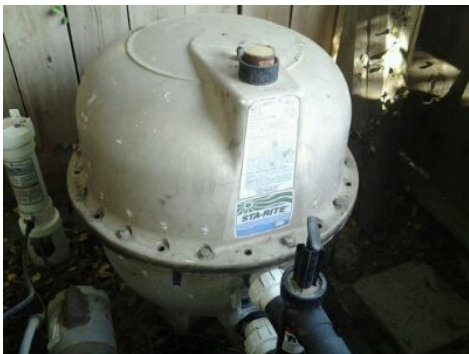
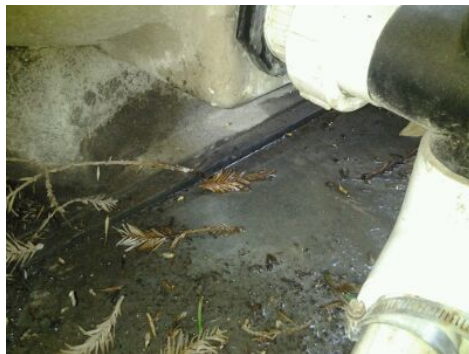
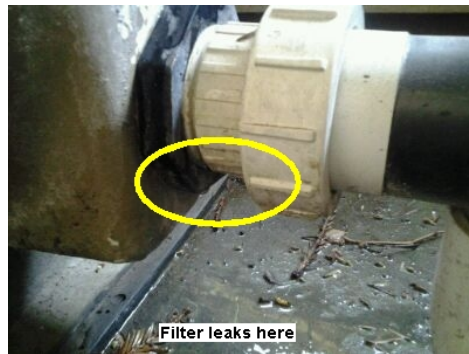
- In operation at time of inspection.
- Shows signs of leakage at backwash valve connection to filter.

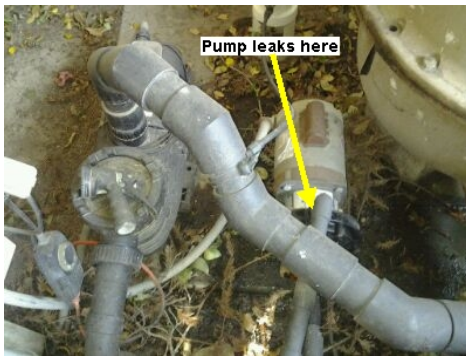
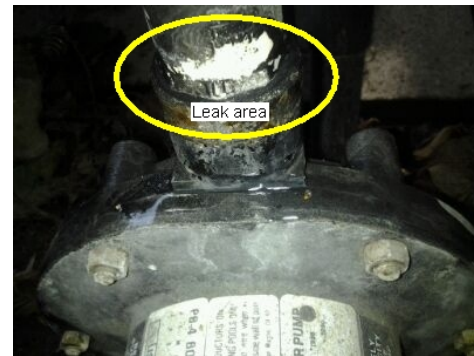
- Operated
- Leaking pump on jet pump.

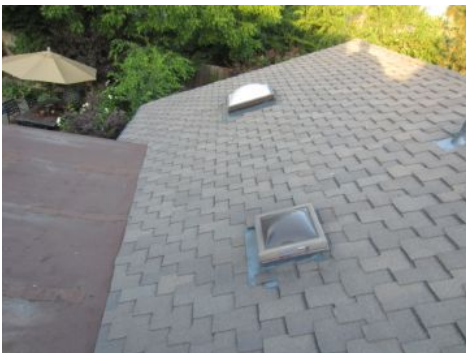
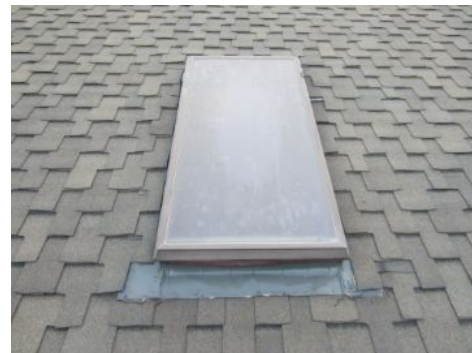
- The roof includes one or more skylights of an older type. Although there was no sign of leakage at time of inspection, we suggest they are looked at on an annual basis as skylight do have a tendency to leak.

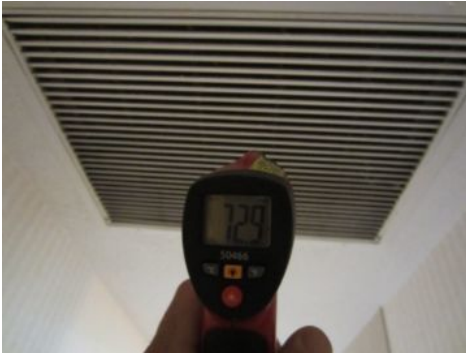
72.9 degrees at return

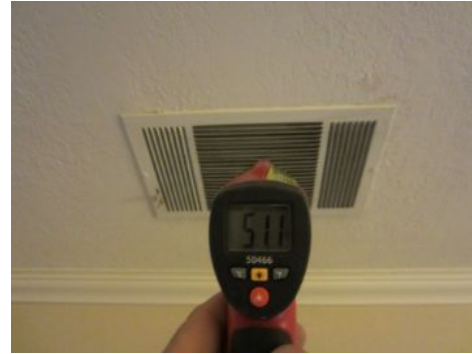
51.1 degrees at supply

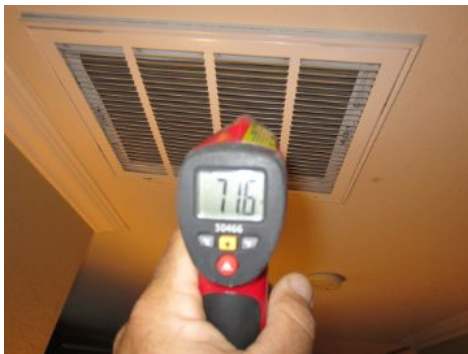
71.6 degrees at return

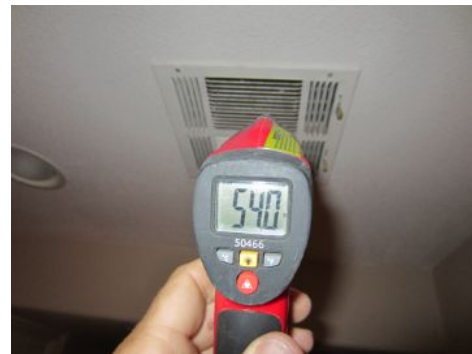
54.0 degrees at supply
